GEOTECHNICAL ANALYSIS OF CARSINGTON DAM FAILURE

Sukiman *

Abstract

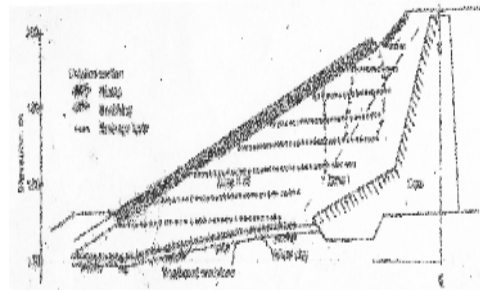
Figure 4. Geometry of the dam at chainage 725 m (before failure)

For this analysis, the geometry of the dam was taken from chainage 725 as presented in Fig. 4. The position of the non-circular failure surface was taken from the approximated failure line in Fig. 3. The input geometry for the SLOPE programme is presented in Fig. 11.

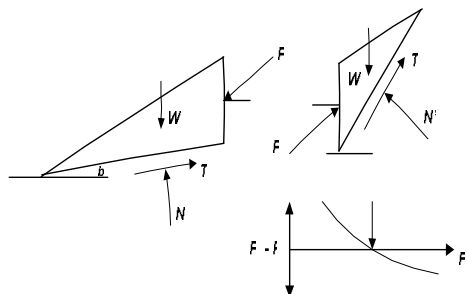
Figure 9. Simplified two-wedge model of the cross section at chainage 725

From Fig. 9 above, the magnitude of P_1 and P_2 can be found from a polygon force providing an assumption about its inclination $q = f'_m$ or $\tan q = \tan f' / F$, where f'_m represents the mobilised angle of shearing resistance. The magnitude of total force W_1 and W_2 were obtained from the area of each wedge multiplied by the unit weight of soil.

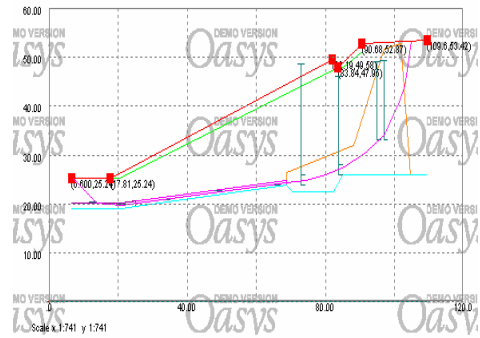
Figure 12. Position of the piezometer grid at the input geometry

The values of pore pressure ratio (r_u) were 0.42, 0.53, and 0.00 for the core, boot, and yellow clay respectively. Because of the limitation of the SLOPE software, the information had to be inputted in the form of a piezometric grid (Fig.12). The piezometer water level can be calculated using the equations as follow:
